A guide for MOCOPA Operators on the types of Distribution Business equipment that may be encountered as part of their work

Cut Out Glossary

V1.1 **Published** 18 November 2020

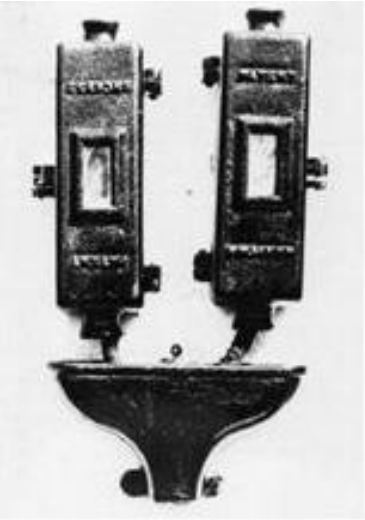
Embargoed	
Manufacturer: 3.3 Unknown	Type: Unknown

- Fused neutral (B11)
- Fuses non-withdrawable by design (B05)

Follow the MOCOPA Guidance for Service Termination Issue Reporting using the appropriate code.

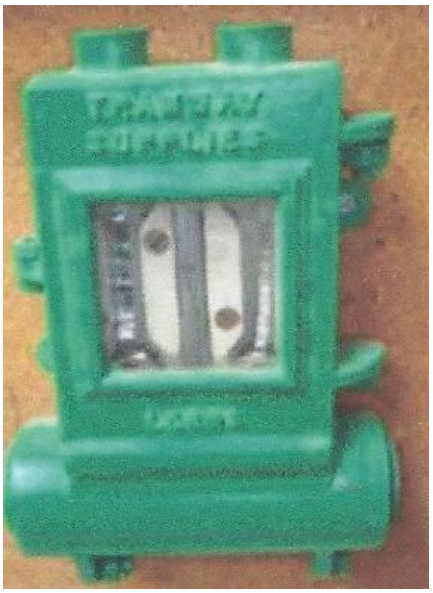
Embargoed	
Manufacturer: 3.13 Tramway	Type: Tramway supplies Leeds

- Pads behind fuse wire may contain asbestos (A12 or C11)
- Fused neutral (B11)
- Fuses non-withdrawable by design (B05)

Follow the MOCOPA Guidance for Service Termination Issue Reporting using the appropriate code.

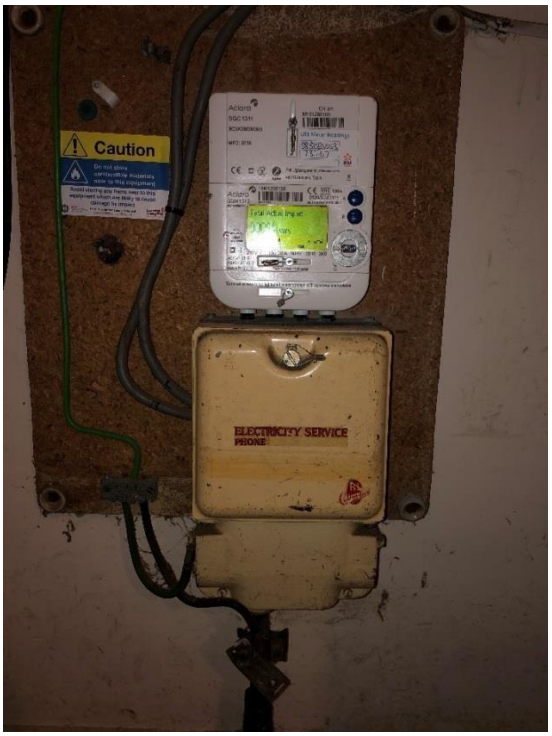
Potential Issues	
Manufacturer: 4.13 BICC or BI Callenders	Type: Biscuit Tin

- Meter can be close coupled so holes may need to be adequately sealed if meter is relocated
- Bitumen can have sunk back in bottom of chamber leaving exposed live cables showing (A07)

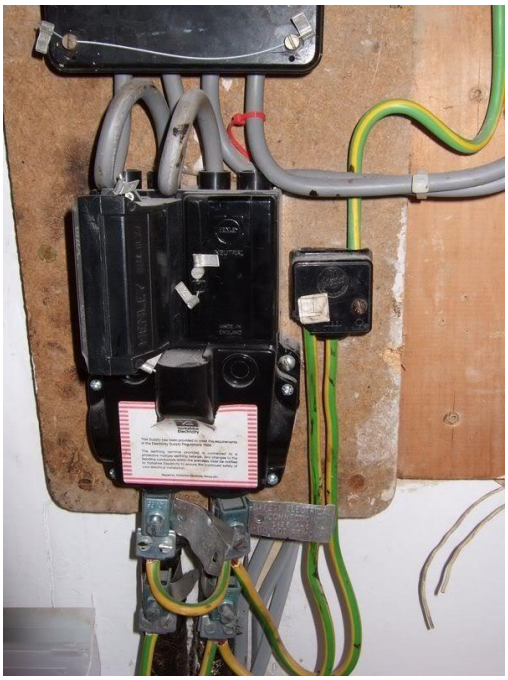
Potential Issues	
Manufacturer: 4.17 Henley	Type: **Series 5 Black Plastic**

- Under certain conditions the cut-out casing can give a live indication (A19).

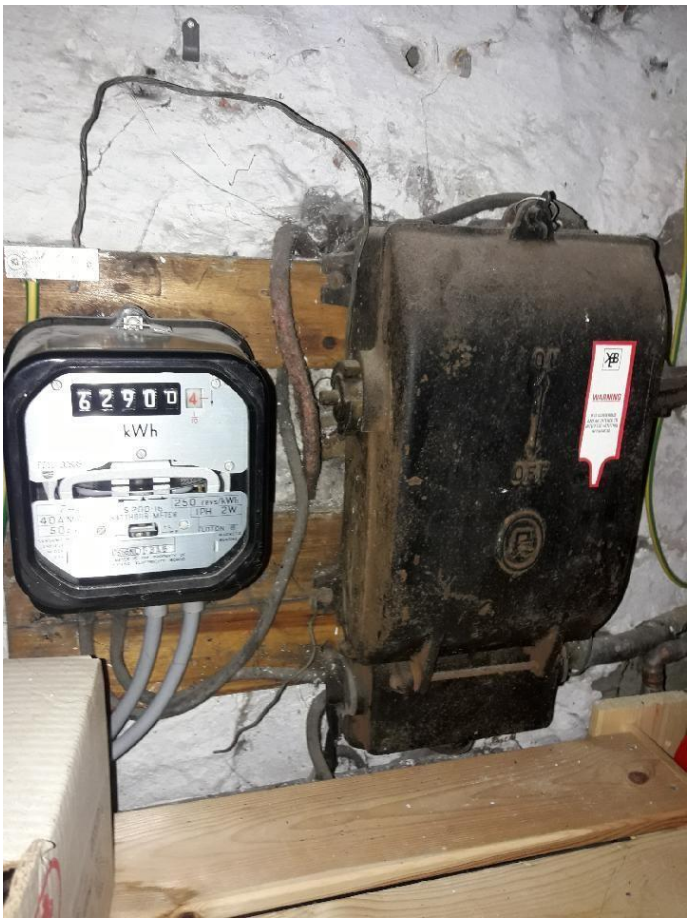
Potential Issues	
Manufacturer: 4.20 Unknown	Type: **Unknown**

- The VIR/cloth neutral cable is connected in the bottom of the cut-out and inaccessible (B07)

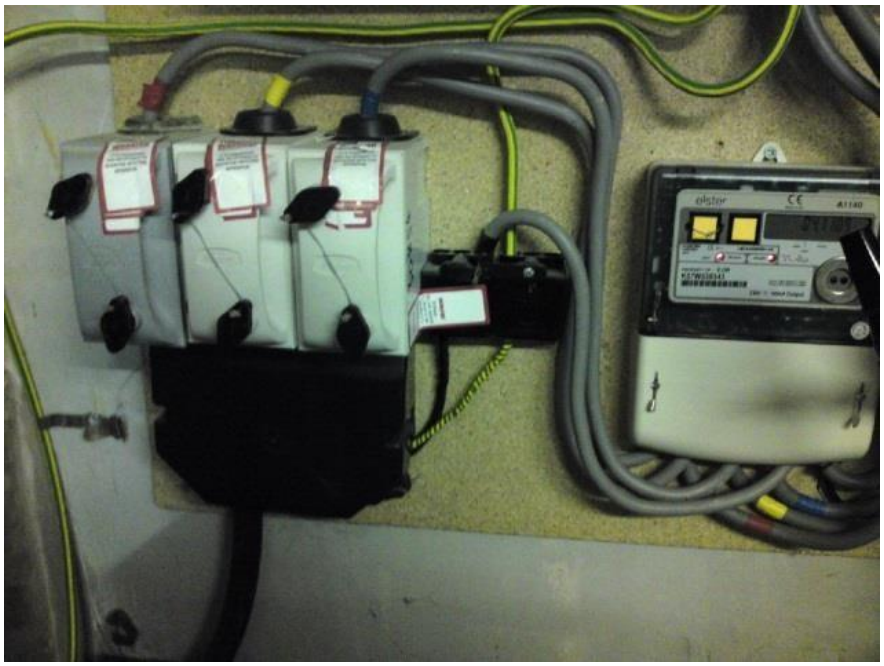
Potential Issues	
Manufacturer: 4.22 Converted Lucy Oxford	Type: **Non-Standard**

- If fuseways are not installed tightly to the service head, live conductors may be left exposed (A07)

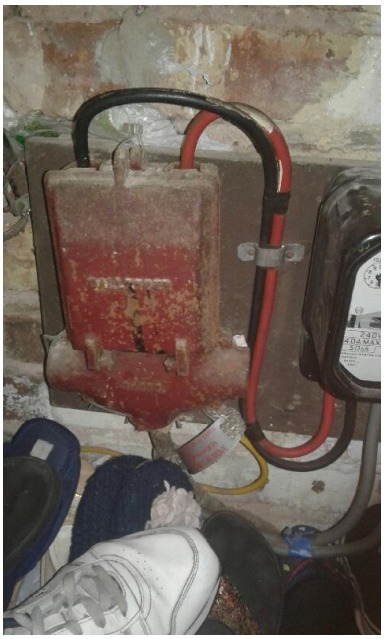
Potential Issues	
Manufacturer: 4.23 Unknown	Type: Unknown

- Hinges may be broken (A04 or B08)

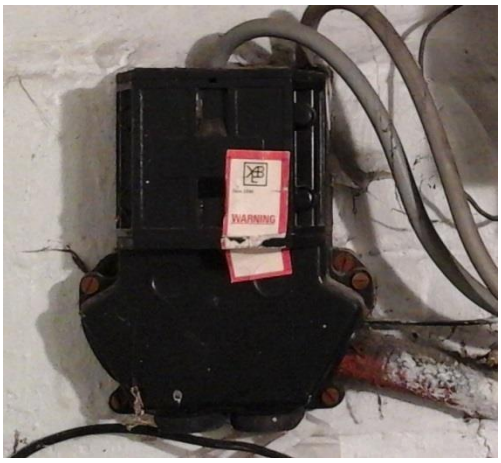
Potential Issues	
Manufacturer: 4.33 BICC	Type: **Black Plastic**

- Under certain conditions the cut-out casing can give a live indication (A19)
- These cut-outs can contain a third terminal (2nd live). This third terminal is a core previously used for local authority communal lighting or heating schemes and is switched remotely so can become unexpectedly live

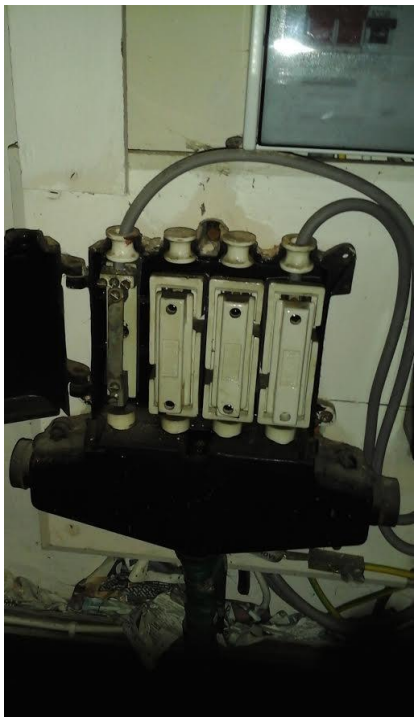
Potential Issues	
Manufacturer: 4.34 Unknown	Type: **Unknown**

- Hinges may be broken (A04 or B08)
- Fuse carrier may contain asbestos pad (A12 or C11)
- Phase barriers may be asbestos (A12 or C11)
- May contain rewirable fuses (C18)
