Guidance for Service Termination Issue Reporting

A guide for MOAs on reporting and acting on Distribution Network Operator asset condition issues

V4.4 **Published** 19 June 2026

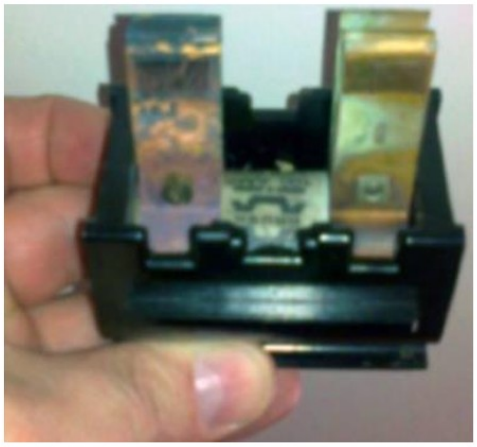
Asset Condition Code:	Code Description:
A03	**Defective/weakened fuse carrier**

For **METAL-ENCASED** cut-outs and distribution boards:

- Remove the fuse from the fuse carrier;
- Close the cut-out or distribution board cover and re-seal to ensure that the installation is secure.

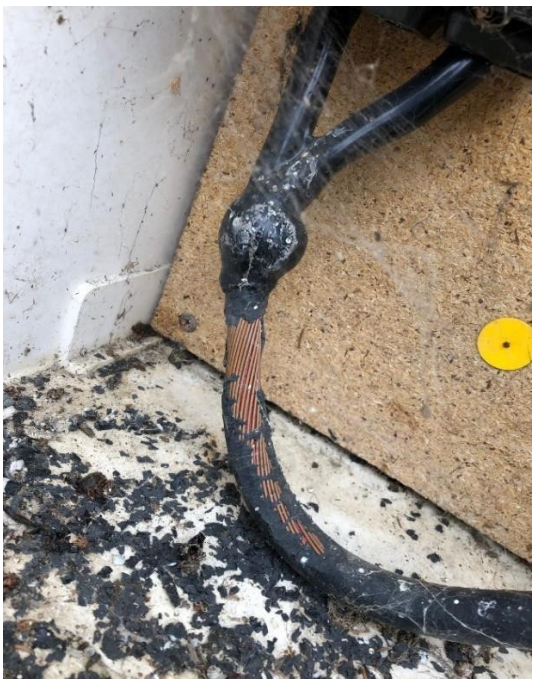
The DNO equipment is damaged e.g. broken or severely cracked/damaged cut-out casing or service cable that requires immediate action (see detailed guidance below).

- Squashed / deformed service cables (e.g. the cable is squashed flat);
- Cables with severely damaged outer sheathing (e.g. where the conductor itself is visible). As the extent of the service cable damage is often unknown, severely damaged service cables should be reported as A04 regardless of the supply earthing arrangement.

Severely damaged cut-out casing

Severely damaged service cable

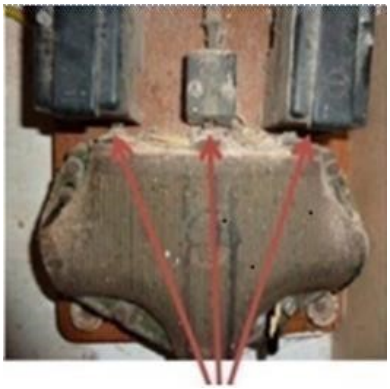
Photo examples – Exposed conductors
These are examples of cut-outs showing visible bare conductors from the cable termination to the fuse unit.

Visible bare conductors

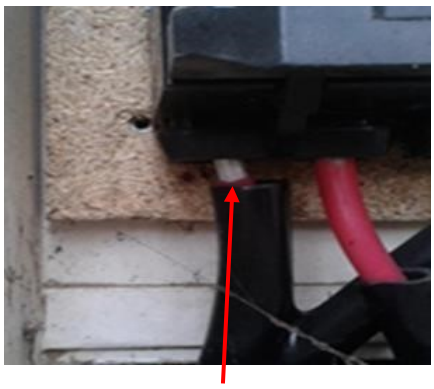
Exposed live conductor where the insulated trousers have slipped exposing the live conductor

Visible bare conductors

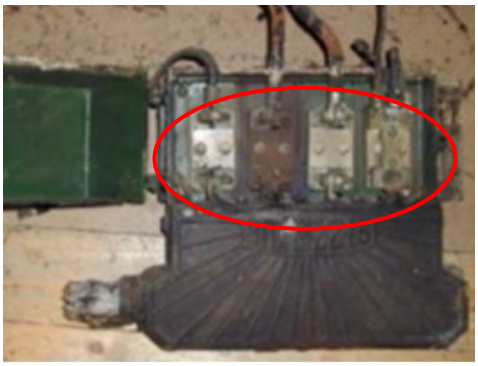
Missing phase barriers. Note the proximity of the incoming 'stalks' to the metal cover

- Wherever possible, for safety and security reasons ensure the DNO equipment is sealed before leaving site;
- Stop work and do not commence your meter installation activity;
- Report the issue to the DNO via the data flow system – report as Code B03;
- Provide the DNO with the customer's name and contact number using the data flow system;
- To ensure the customer is fully aware of next steps, leave a Category B Customer Notification Card (or equivalent) to advise the customer to expect communication from the DNO requesting an appointment to visit site to inspect the DNO equipment.

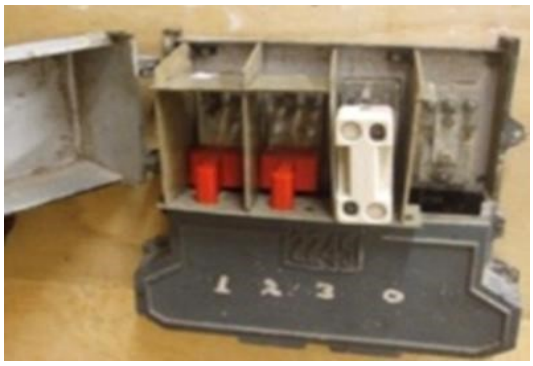
Missing phase barrier. Shrouds (in red) have been used by the Meter Operative to cover the live terminals

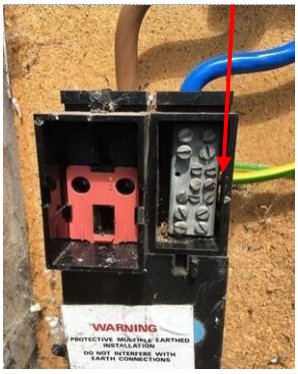
The screws are designed to be tightened by hand with the appropriate sized screwdriver or tool. If in the course of tightening you shear the screw you may be using excessive force and the screw will be adequately tight. These would not need to be reported under this Code.

If during the course of your works you shear off a termination screw and you cannot confirm tightness report as Code A01 and remain on site for the DNO to attend.

Note: In circumstances where spare screws and terminals can be utilised the meter exchange can take place and you should not report a defect to the DNO, providing any redundant entry points can be made safe, e.g. by insertion of a blanking plug.

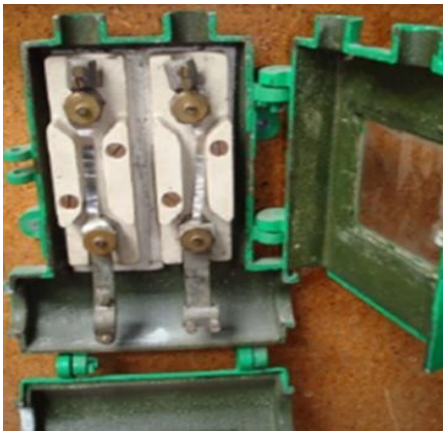
The photos below show an example of a cut-out where the fuse wire terminals are attached to the cutout, hence the fuse is non-withdrawable by design. Although note that this particular cut-out also contains a fused neutral and would therefore be reported under as Code B11.

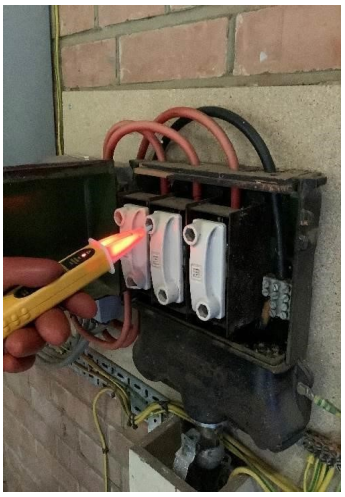
The photos below show an example of a cut-out where the fuse carriers can only be withdrawn by loosening the live screws integral to the porcelain carriers. This is considered live working and is not within the scope of Meter Operative activity.

If the withdrawal of the above fuse carrier types is required to continue with your work, you should report the issue to the DNO via Code B05. The DNO will decide to take one of the following actions:

i. The DNO will make arrangements with the Meter Operator Agent for a simultaneous site visit for DNO staff to withdraw the fuse to enable safe working to continue. The DNO staff will re-insert the fuse when works have been completed. To enable this option to be followed-up, Meter Operators should provide their contact details when they report this code to the DNO.
ii. If space on site permits, the DNO may choose to install red-link cut-outs above the existing cutout to facilitate Meter Operator Agent works in the future.
iii. The DNO will make arrangements with the customer to attend site and replace the cut-out.

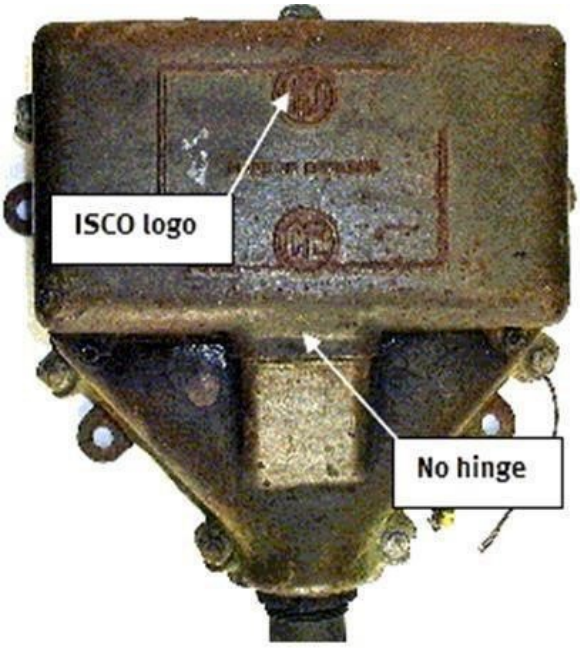
An uncommon type of pressed steel metal-encased cut-out, probably from the 1940s.

A typical example of a metal-encased cut-out which has known design deficiencies is the ISCO Type cut-out and extreme caution must be exercised when removing or replacing lids on this type of equipment. This particular example also had the phase barriers removed. All cut-outs must be assessed individually prior to attempting any live work on them ensuring that the phase barriers are in place.

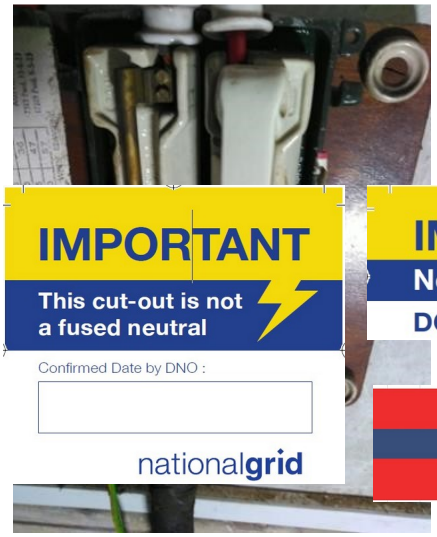
Examples appropriate to report as B11

Not reportable as a B11 code. Report as appropriate C code (i.e. C11 or C18)

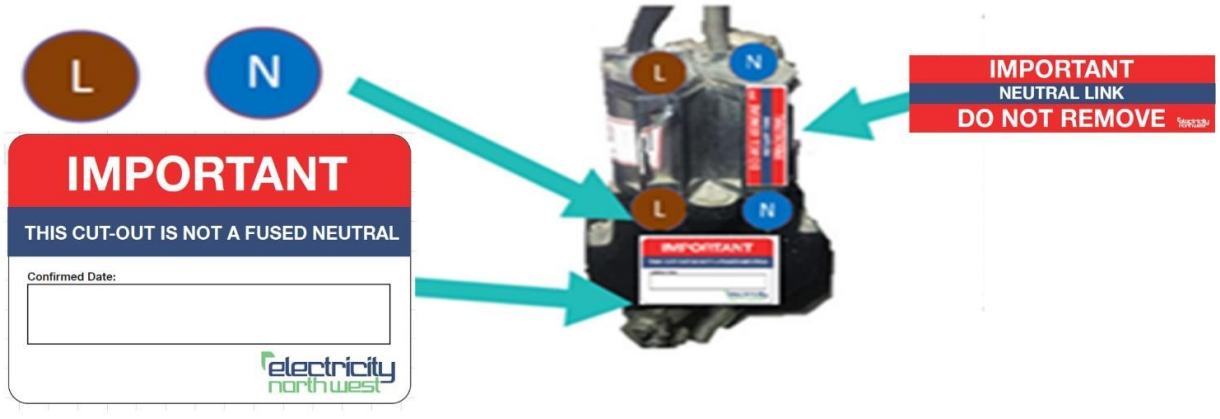
Usual Placement of Labels

Example of labelling added to removable neutral carrier – to remove risk of incorrect reporting- not reportable as B11.

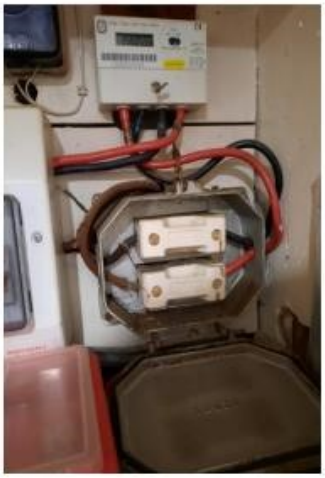
Not reportable as B11 to DNO, raise with building owner as it is a BNO asset.

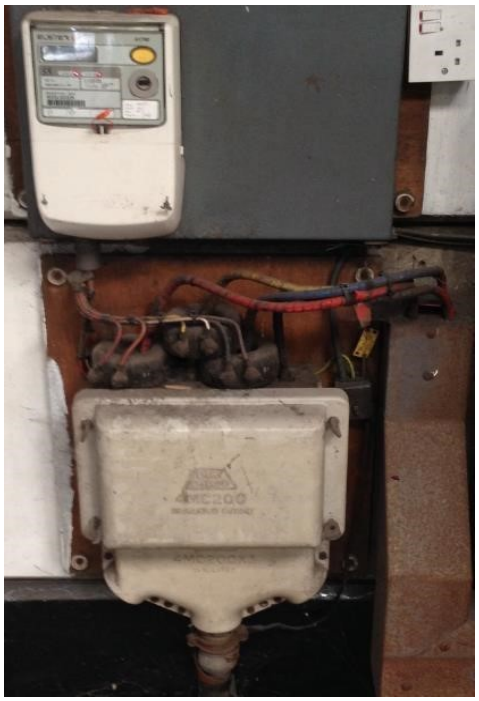
- Damaged or insecure meter panel or CT chamber;
- Damaged CT or VT;
- Damaged wiring loom (up to the point of interface, such as the test terminal block and/or fuses/link);
- Shorting links on CT applied that cannot be accessed by the Meter Operative;
- Test terminal block missing or faulty;
- VT primary fuse blown;
- Inaccessible or non-standard types of VT secondary and LV metering potential fuse blown Although VT secondary fuses and metering potential fuses up to and including the point of interface are the responsibility of the DNO, normally it would be sensible for the Meter Operative to replace blown fuses,

CT installation with missing test terminal block

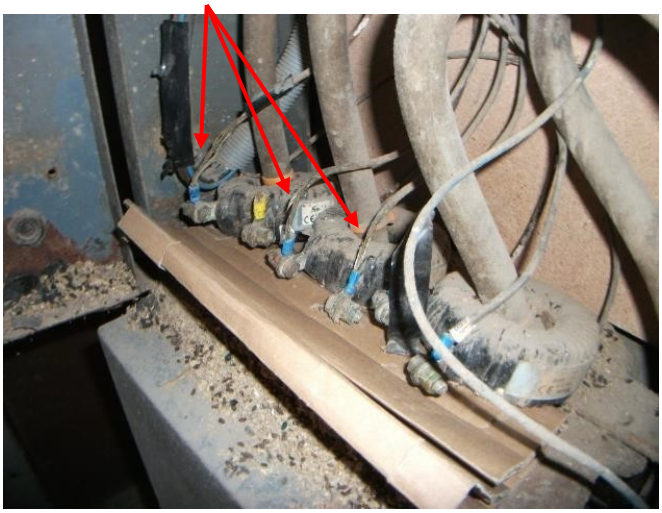
CT wiring insulation damaged by rodent infestation exposing inner conductor

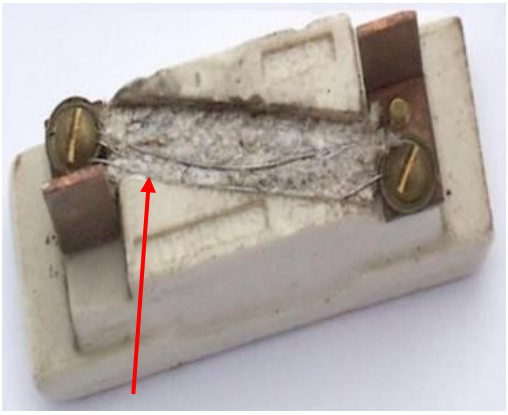
On removing the cut-out or distribution board cover or fuse (usually in metal-encased cut-outs) materials used for the phase barriers or as arc suppression or protection from heat are suspected to be manufactured from asbestos containing material.

Note: If the asbestos is damaged; report as Code A12.

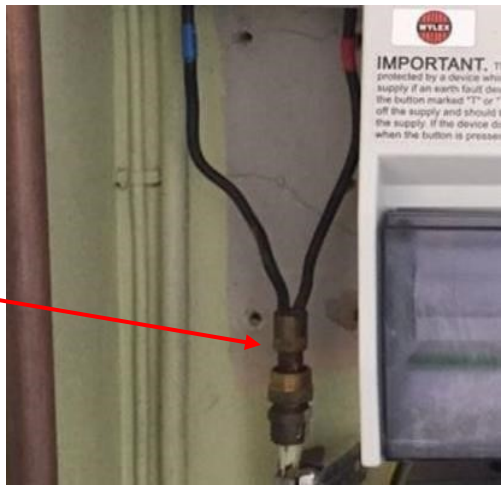
Examples of MICC cable

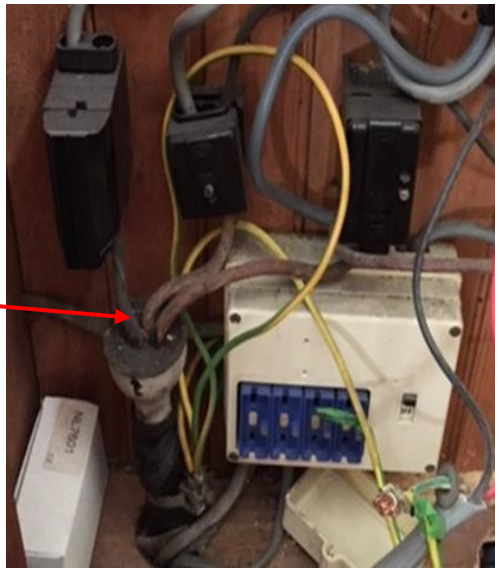
Example of VIR covered conductor

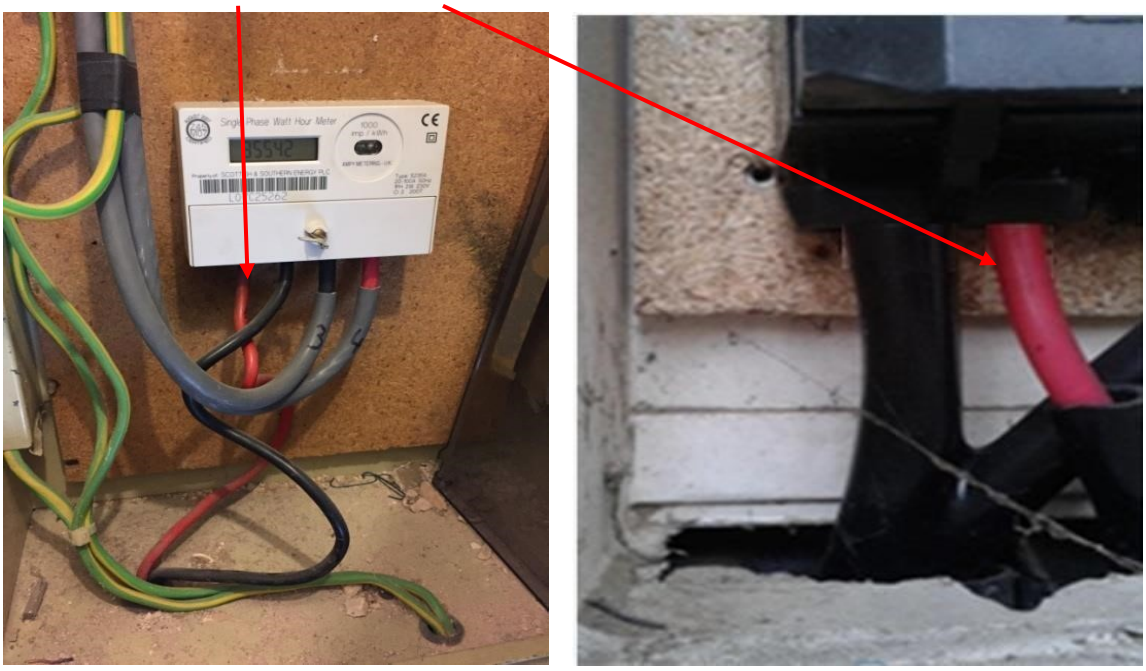
This Code should be used for reporting incoming service cables to the DNO equipment which are in a serviceable condition but have single insulation covering the conductor(s) and are not mechanically protected.

- Missing service cable crutch cover (on non-PME service);
- Insulated trousers which have slipped down the service cable crutch.
